Manhole Inspection Summary

Manhole # S21Y__012MH

Insp Date: **11/24/08 1:24 PM**

Location Address: **2027 HOLLINS FERRY RD**

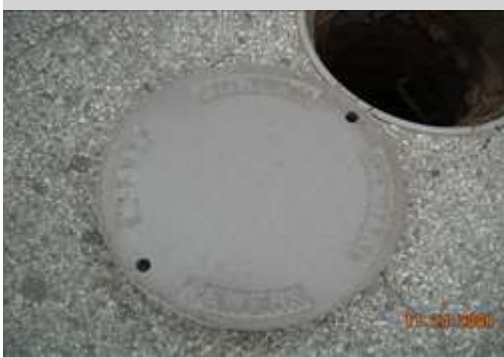
Miscellaneous

Condition: **Worn**

WORN COVER

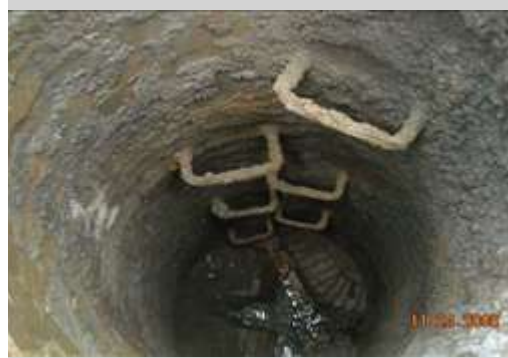
Defect 5

☒ **Joint**

☒ **Wall**

☒ **Corroded**

corroded steps, chimney infiltration from joint & wall, corbel infiltration from wall

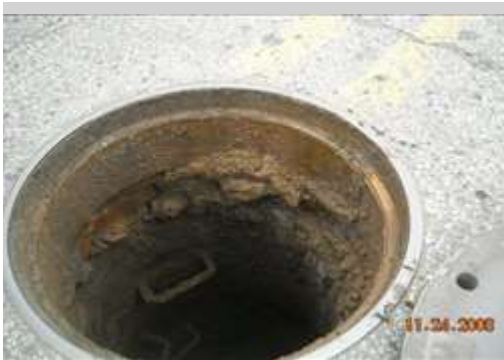
Defect

Subject To Ponding: **Sheeting**

☒ **Leaks**

FRAME LEAKS_INFLOW EVIDENCE FROM SHEETING

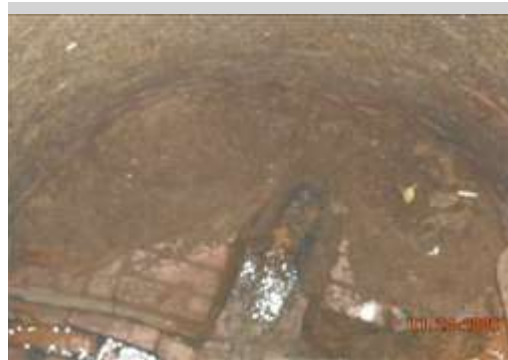
Defect 4

☒ **Debris**

DEBRIS ON BENCH

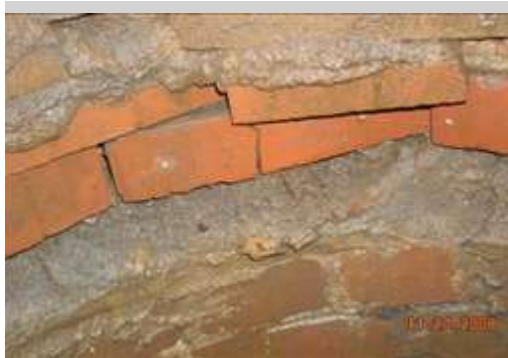
Defect 3

☒ **Cracked**

CRACKED CHIMNEY BRICK

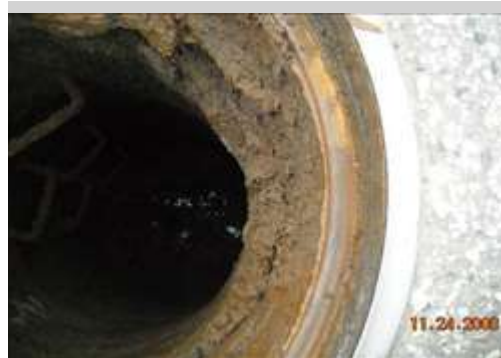
Defect 2

Offset: **1.5** (in.)

FRAME OFFSET

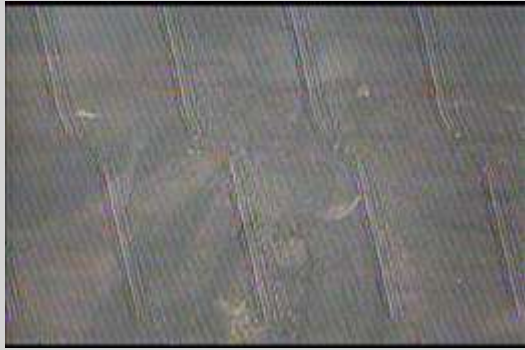
6 O'Clock Inflow

Deposits: ☐ None ☒ Mud ☐ Sludge ☒ Debris ☐ Grease

Silt Depth: 8 (in.) Deposits Extent: Heavy

Connects To: Stub connection / abandoned

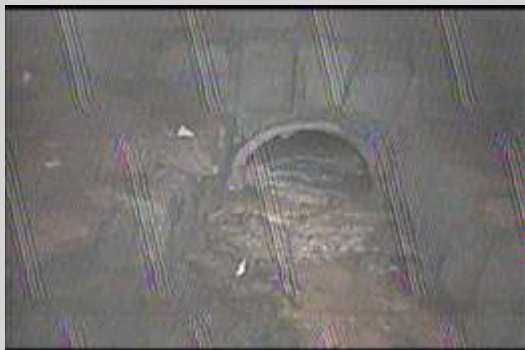
8 O'Clock Inflow

Deposits: ☐ None ☒ Mud ☐ Sludge ☒ Debris ☐ Grease

Silt Depth: 4 (in.) Deposits Extent: Heavy

Infiltration: None Pipe Seal Cond: Cracked
